**MONITORING COMPLETED COASTAL PROJECTS PROGRAM**

MISCELLANEOUS PAPER CERC-91-10

**MONITORING OF COMPLETED BREAKWATERS  
AT CATTARAUGUS CREEK HARBOR, NEW YORK**

September 1991

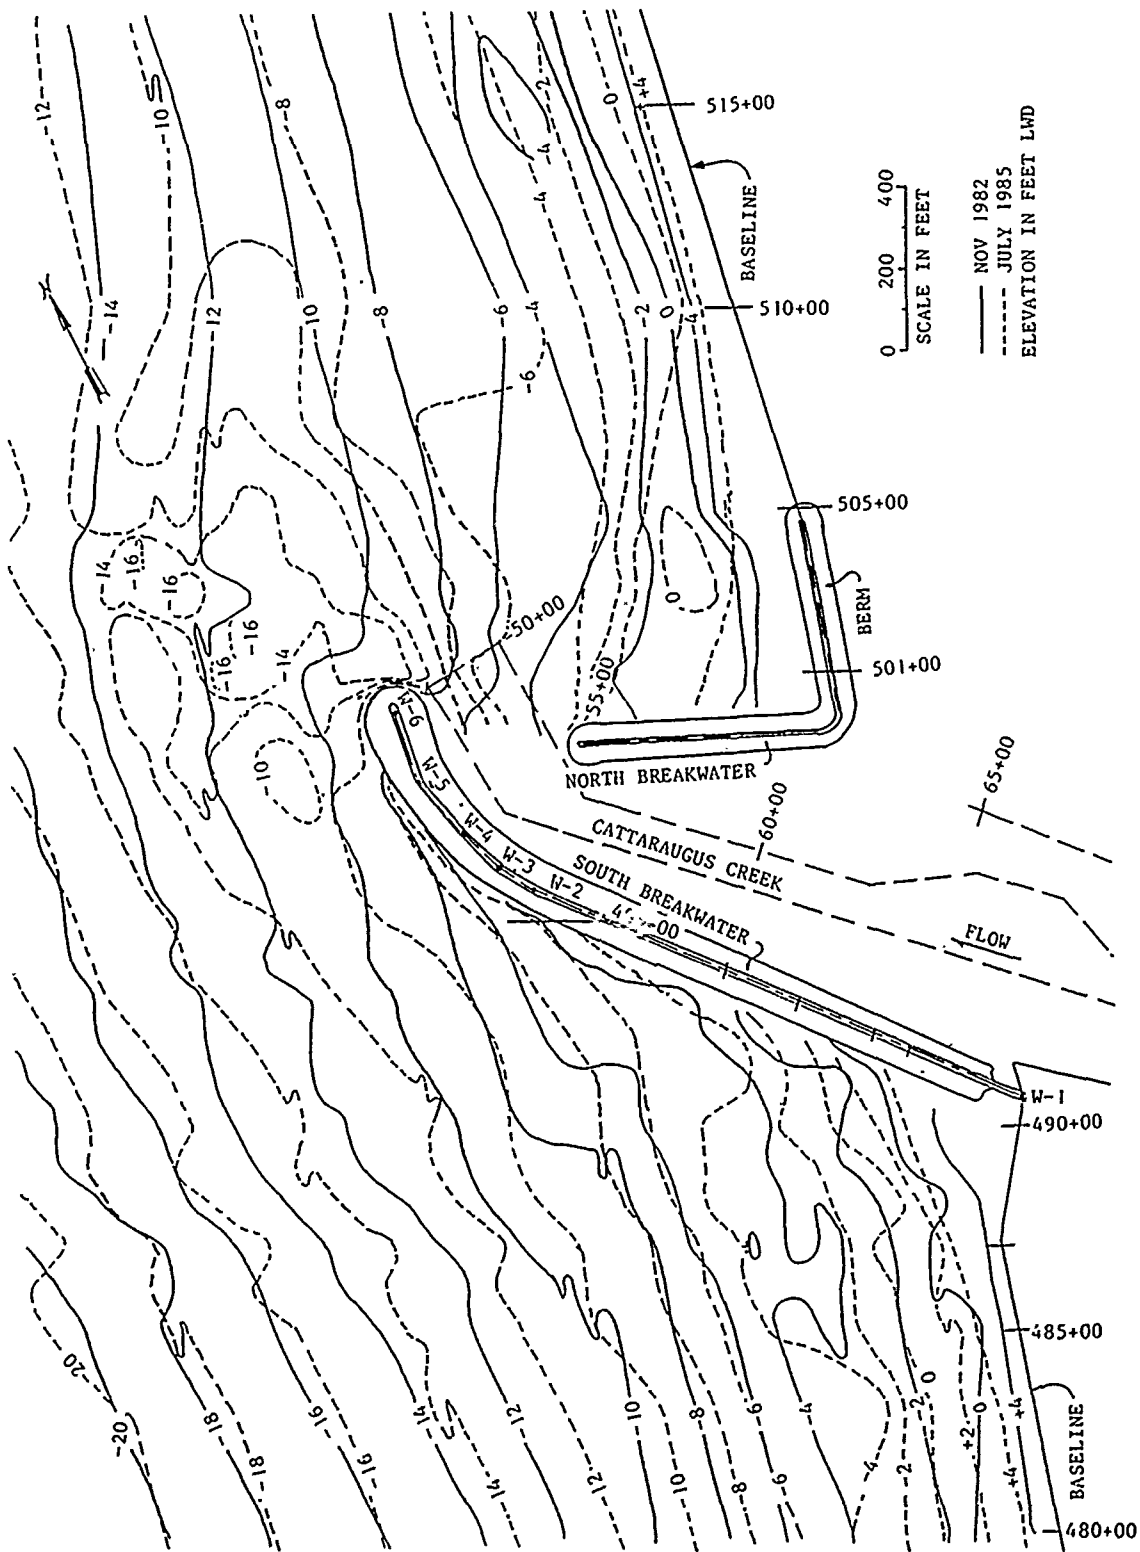
Figure 50. Cattaraugus Creek Harbor,  
26 October 1985, +3.5 LWD

92. The use of filter fabric was successful, at least to date. There were obvious indications of transport through the south breakwater lakeward of where the fabric had been installed (Figures 50 and 51). Figure 50 shows conditions with waves entering the mouth of the creek and pushing more sediment-laden water through the structure. Figure 51 shows the opposite conditions, with the clearer lake water penetrating into the channel. These are indications that sediment has been prevented from penetrating the structure and reaching the channel where filter fabric has been used.

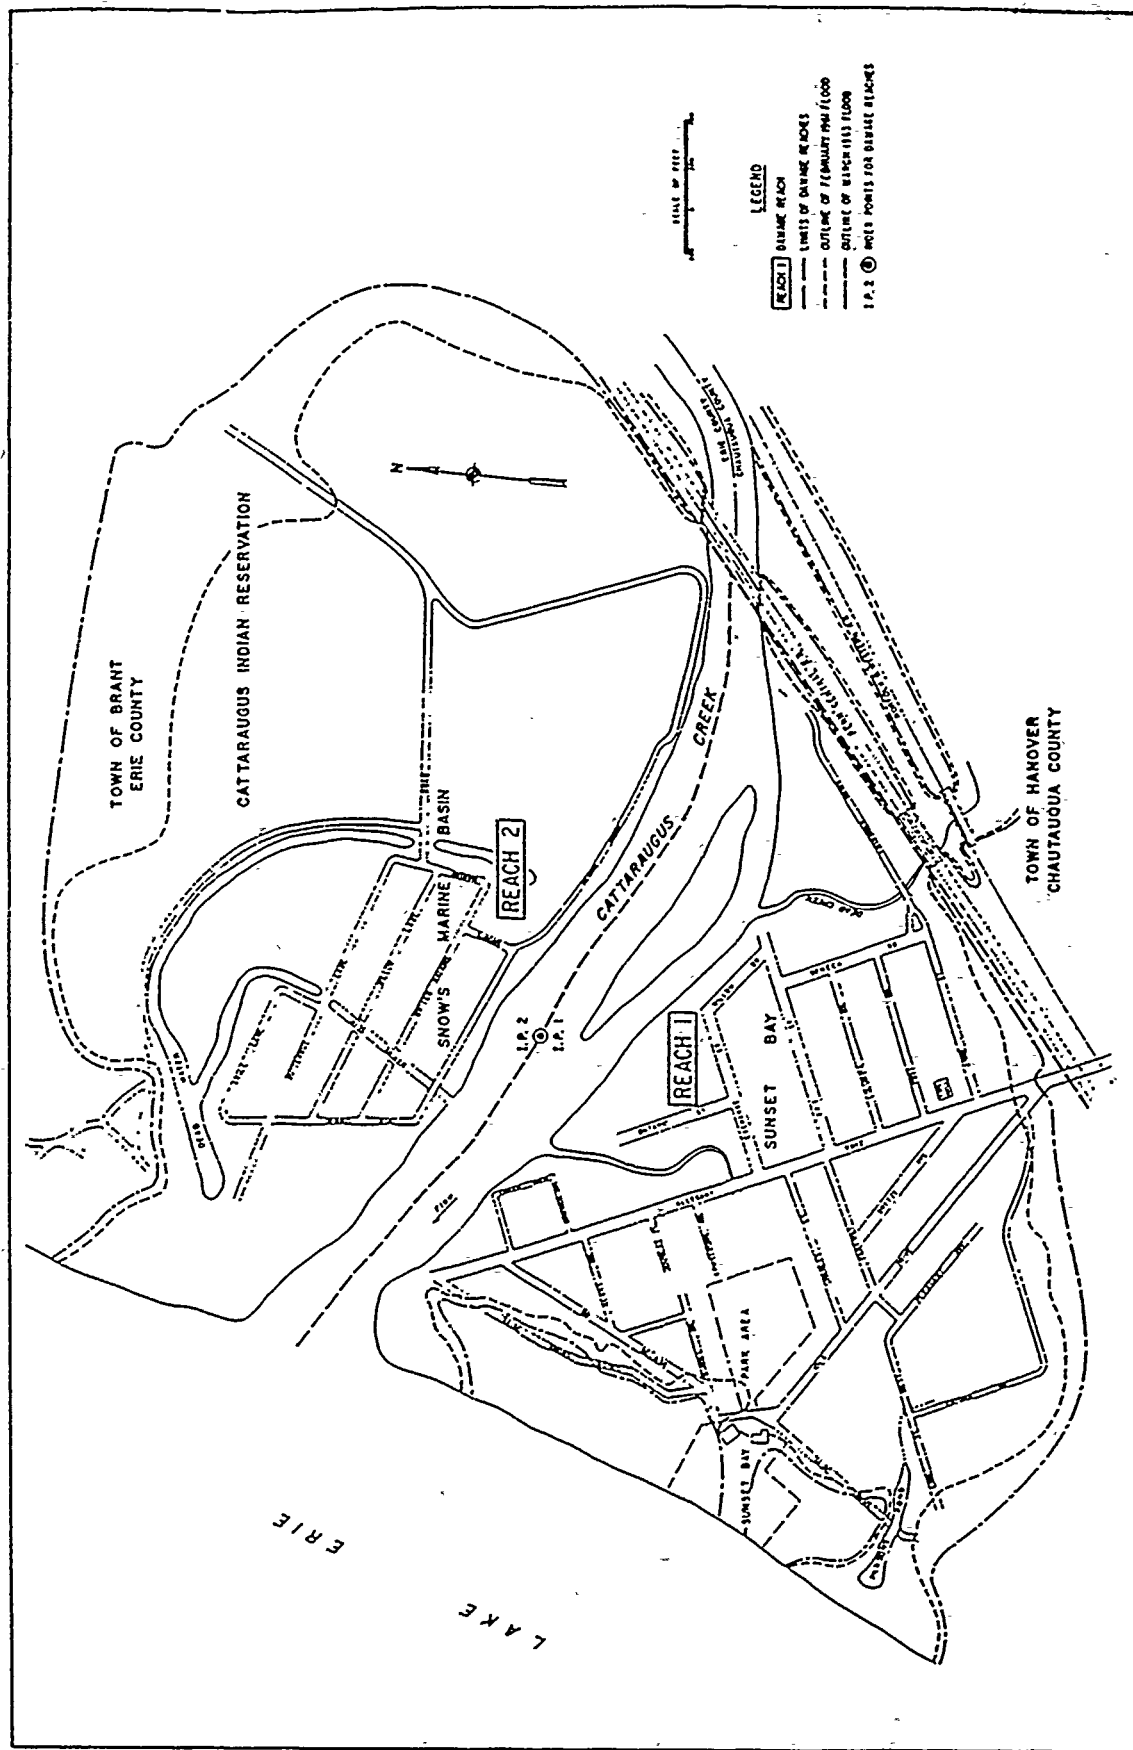
Figure 94. Flooded outlines for the 1961 and 1963 ice jam

windrowed lake ice in the winter. As the channel filled, water overflowed the banks just below the railroad bridge. On the right bank, the water and ice traveled overbank to an old abandoned channel of Cattaraugus Creek. The velocity and strength of the water opened this abandoned channel to the lake and provided an outlet for part of the floodwater. On the left bank, the floodwater and ice passed over the low banks downstream of the railroad embankment and passed through Sunset Bay to the lake. The flood found two avenues at the lake, one through the area known as Parson's Pond and the other at a relatively low section of the beachfront near Iola Drive. Figure 94 presents flooded outlines for the 1961 and 1963 ice-jam floods.

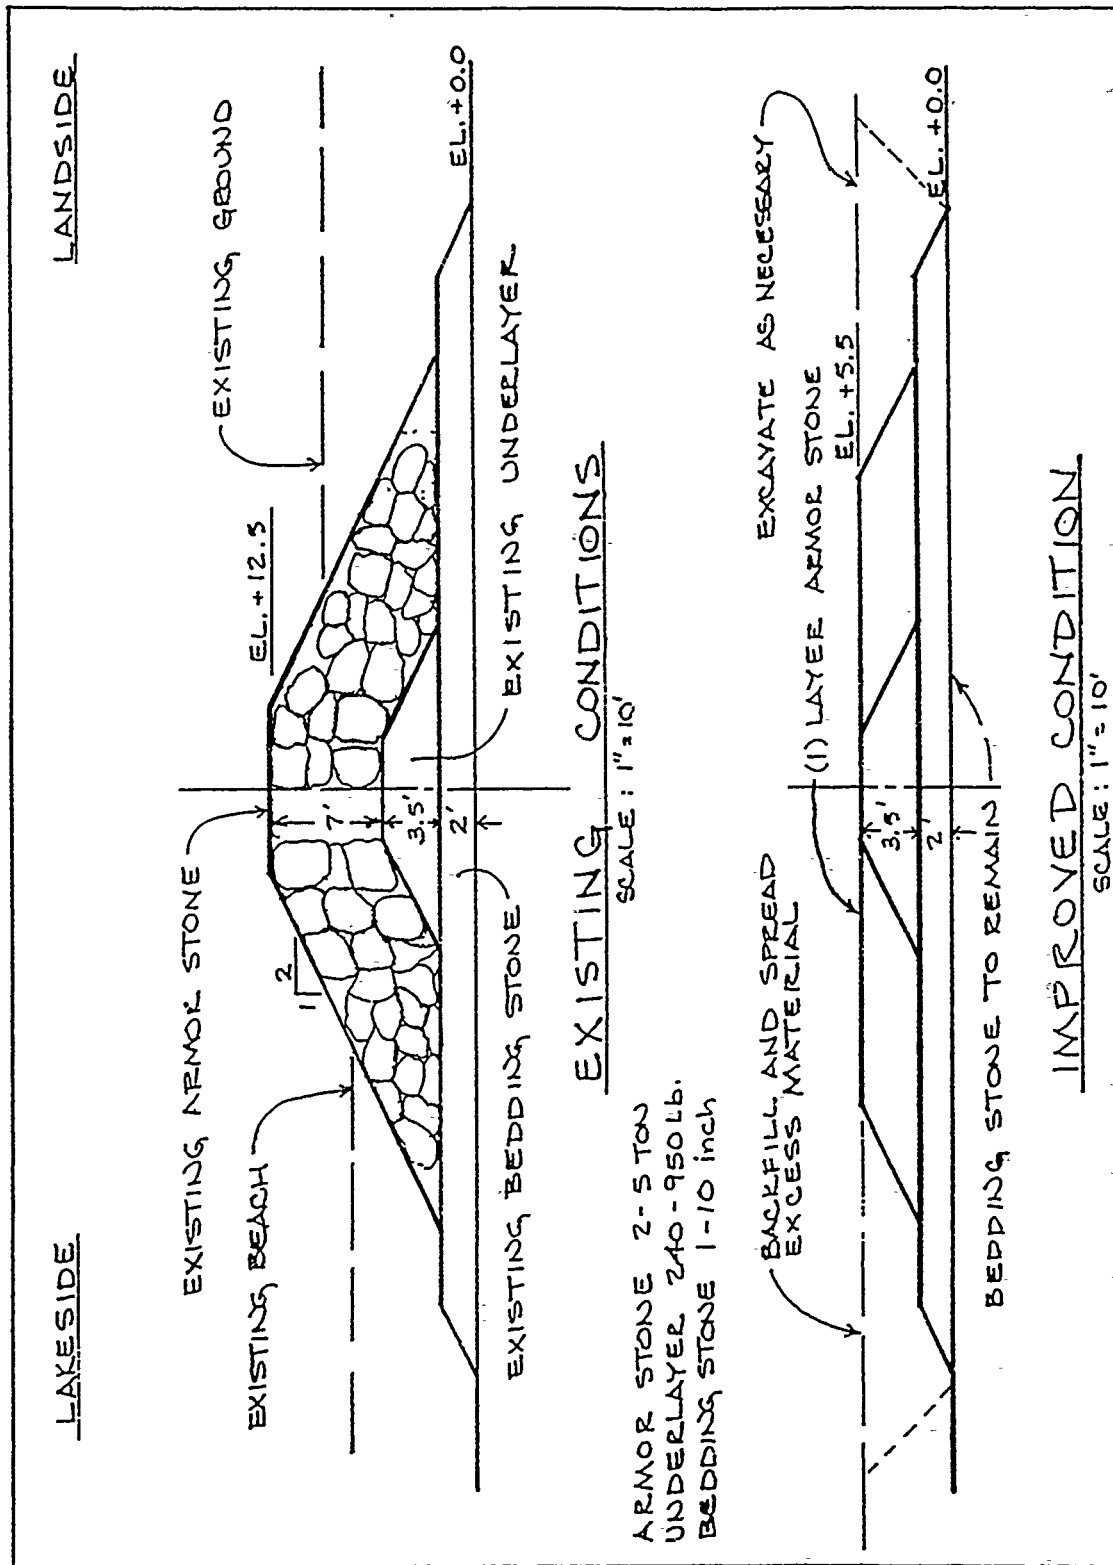
Figure 97. Sketch of cross section for berm height reduction

75. To alleviate the increased flood damages estimated at \$87,800 on an annual basis (USAED, Buffalo 1987), a rectification project consisting of lowering the north breakwater berm from +12.0 to +5.5 ft LWD was proposed. A 400-ft length of the berm was proposed to be lowered with construction scheduled for the summer of 1987, provided that a right-of-entry be obtained from the Seneca Nation of Indians. It was not obtained, and there is little potential for implementation in the foreseeable future. Figure 97 presents the proposed modified berm cross section.

76. The reduction in the berm crest height was estimated to reduce average annual damages by 50 percent but would not prevent ice-jam formation. Possible solutions were identified during the Cattaraugus Creek Study (USAED, Buffalo 1987) and evaluated in a two-stage iterative process. Nine preliminary alternatives in addition to the "no-action" option were initially formulated and assessed. These alternatives fell into two broad categories: local protection plans in areas where a high concentration of flood damages exists (Sunset Bay and Arcade) and dam reservoir plans at Springville. For the plans at Springville, hydroelectric power generating facilities and recreation facilities were also considered to maximize the economic efficiency of the basic flood-control plans.

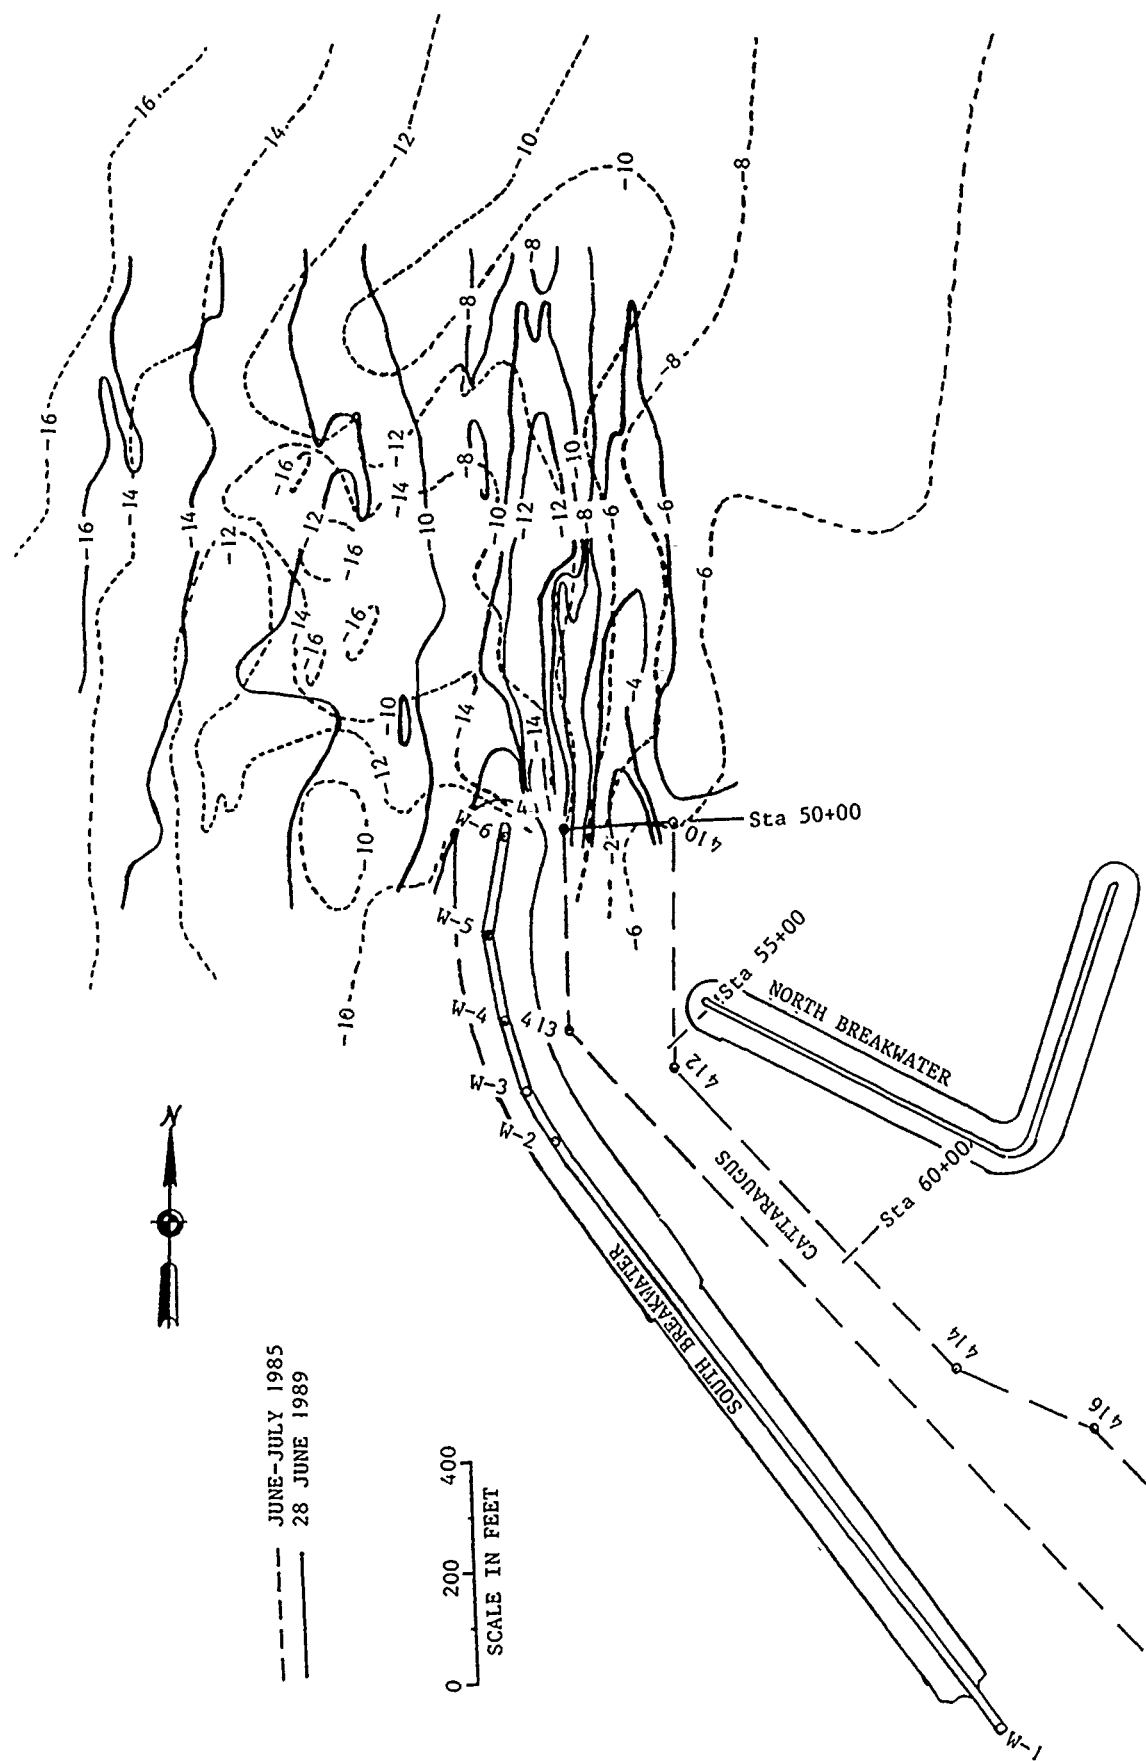
Figure 100. Offshore bathymetry changes in the vicinity of the south breakwater head, 1985-1989

79. As indicated previously, it was observed that a 4-ft scour hole had developed off the head section of the south breakwater some time during the period August 1984 to June 1985. During maintenance soundings of the entrance channel in June 1989, additional soundings in the vicinity of the June 1985 scour hole were obtained. These data revealed that the scour hole had generally filled in except for a very small portion approximately 650 ft from the structure head. Minor offshore steepening had occurred, and a shoal had developed at the mouth of the entrance channel. Figure 100 presents the off-shore bathymetric changes in the vicinity of the south breakwater head.

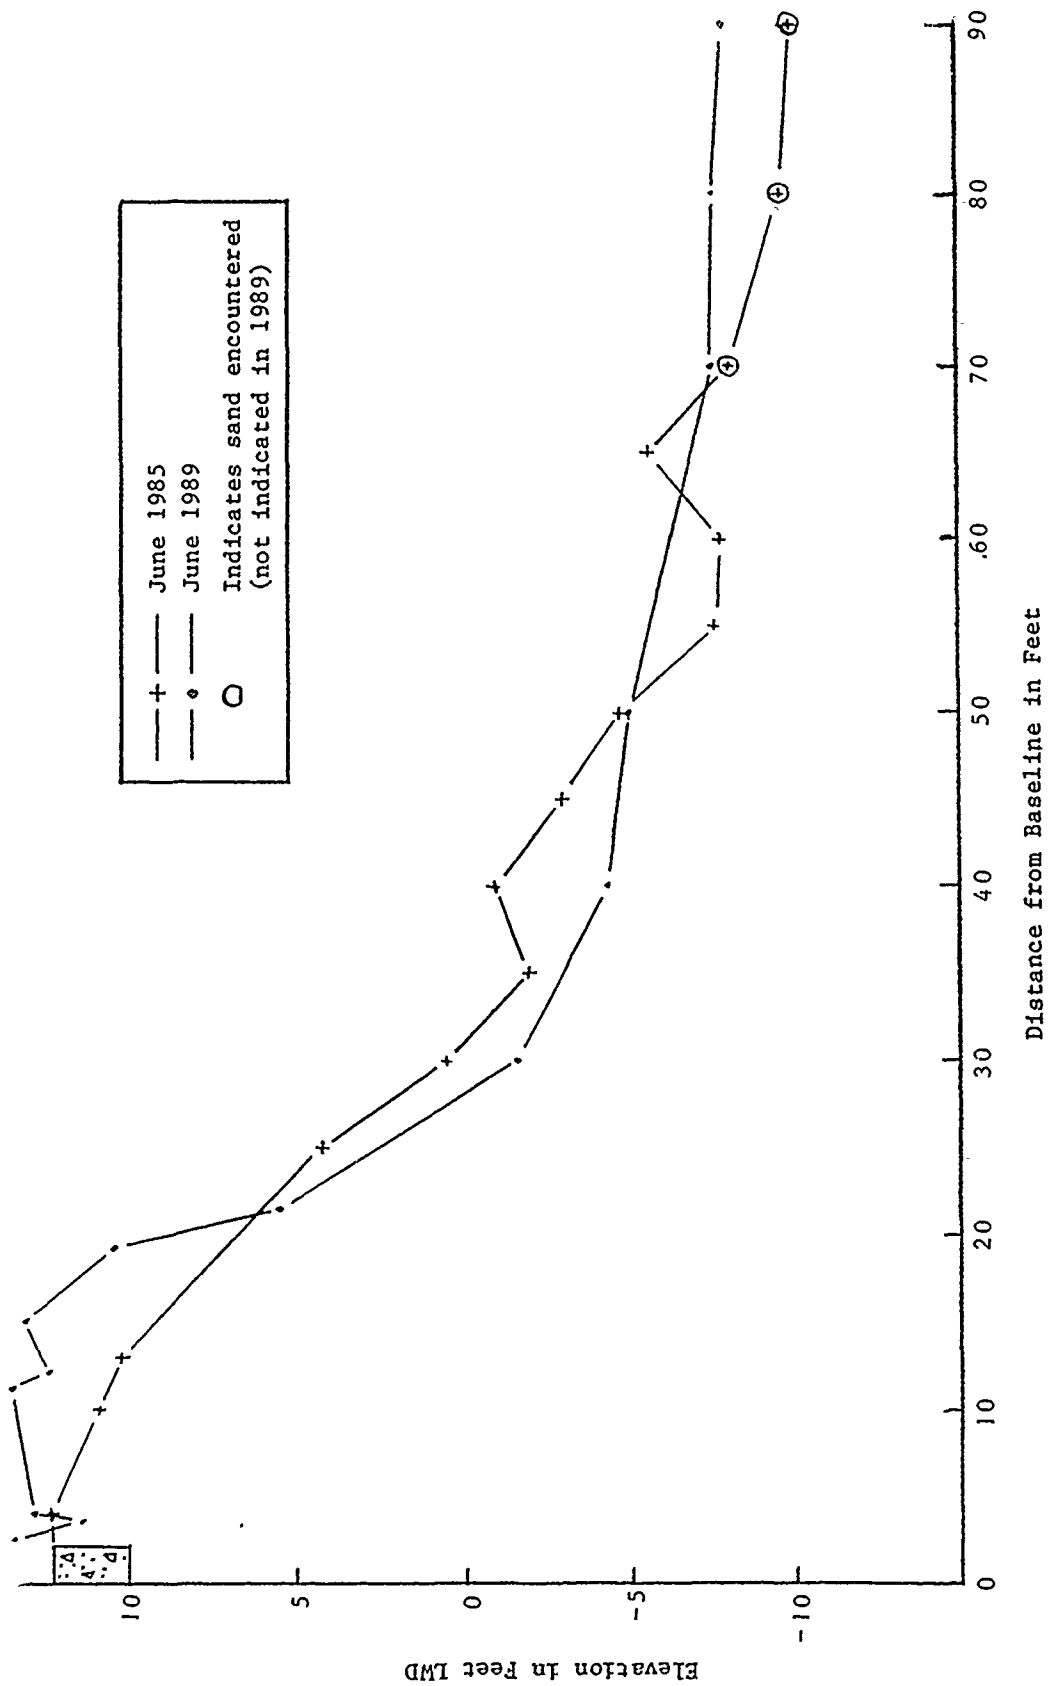
Figure 101. Structure cross section for W-6 (W)

80. Stone locations at Sta W-5 and W-6 were also obtained at this time, as well as structure cross sections. It seems that stone movement at the south breakwater head is continuing, and the structure slope is steepening. It appears that the sacrificial toe berm has probably settled, which may have been the result of the earlier scour, but its presence helped reduce the amount of potential damage. Table 15 presents the change in stone location, and Figures 101-105 present a comparison of the June 1985 and June 1989 cross sections of the south breakwater head.
